**Flood Control Project Maintenance
Levee Inspections**

Maintenance Issue Types Only, Levee Inspection Report By Mile - Fall 2018

Reclamation District No. 0554 Walnut Grove

Waterway	Bank	Unit Miles	Inspection Start/End	Inspector
Unit No. 01 Sacramento River	Left	1.13	10/31/2018 10/31/2018	David Julian

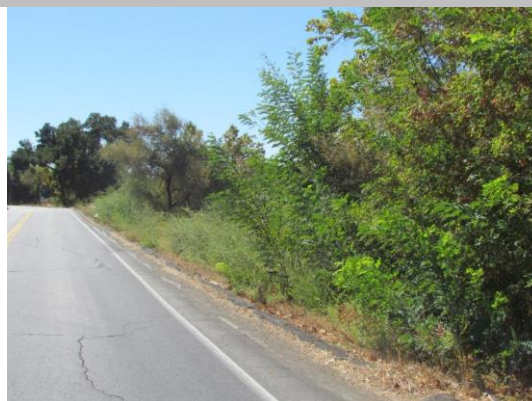
Photo 1 of 1 : FA_2018_RD0554_176_31_20180925_00007.jpg

LM Start	0.02	Rating **	U	Issue No.	31
LM End	0.17	Issue Type +	Ma	Location *	WS
Category	Earthen Levee			GPS Latitude/Longitude	
				Start	End
Item	Vegetation			38.249449 °	38.247375 °
				-121.510017 °	-121.509990 °
DWR ID	DWR_RD0554_01_f_2016_31				
Comment Code					
V2 : Remove the wild growth other than native grasses from the levee slopes.					
Inspector Comment					
Remove/reduce wild growth on the waterside to 20 feet from the crown.

Looking downstream waterside levee slope from levee mile 0.08-0.30.

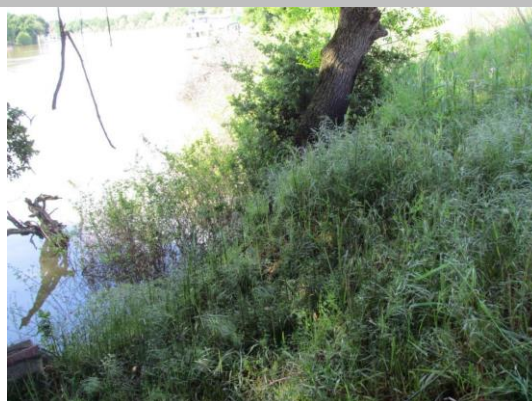
Photo 1 of 1 : FA_2018_RD0554_176_11_20180925_00001.jpg

LM Start	0.10	Rating **	M	Issue No.	11
LM End	0.10	Issue Type +	Ma	Location *	WS
Category	Earthen Levee			GPS Latitude/Longitude	
				Start	End
Item	Erosion / Bank Caving			38.248262 °	38.248262 °
				-121.509901 °	-121.509901 °
DWR ID	DWR_RD0554_01_s_2014_11				
Comment Code					
E1 : Note and monitor erosion site.					
Inspector Comment					
This is not a new erosion site, repairs are needed. One tree has fallen into the Sac River at the erosion site. This site can be seen better from the river by boat. The wild grapes blocks the view from the waterside shoulder looking down the slope. Rated as M because it is an oversized levee section.

RD 554 Waterside levee slope erosion into the bank, the wild vegetation growth blocks the view.

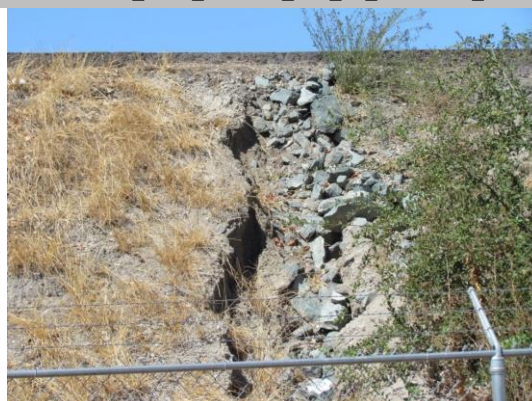
Photo 1 of 3 : FA_2018_RD0554_176_13_20180925_00002.jpg

LM Start	0.32	Rating **	U	Issue No.	13
LM End	0.32	Issue Type +	Ma	Location *	LS
Category	Earthen Levee			GPS Latitude/Longitude	
				Start	End
Item	Erosion / Bank Caving			38.245389°	38.245389°
				-121.511085°	-121.511085°
DWR ID	DWR_RD0554_01_s_2014_13				
Comment Code					
E2 : Schedule repair of erosion site prior to the next inspection.					
Inspector Comment					
This erosion isn't repaired to date. Large bush growing in eroded gully. Needs repairing.

This erosion along the landside levee slope is not new, it was reported two years ago.

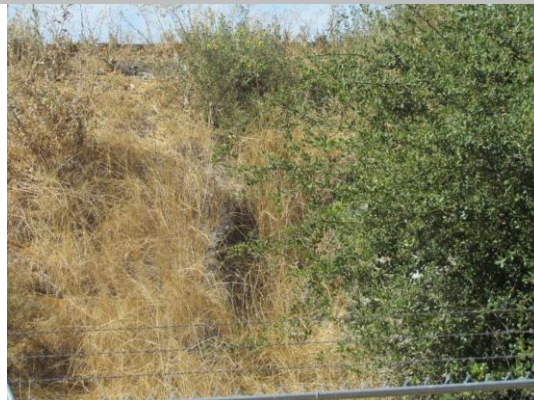
Photo 2 of 3 : FA_2018_RD0554_176_13_20180925_00003.jpg

LM Start	0.32	Rating **	U	Issue No.	13 (cont)	
LM End	0.32	Issue Type +	Ma	Location *	LS	
Category	Earthen Levee			GPS Latitude/Longitude		
				Start		End
Item	Erosion / Bank Caving			38.245389 °		38.245389 °
				-121.511085 °		-121.511085 °
DWR ID	DWR_RD0554_01_s_2014_13					
Comment Code						
E2 : Schedule repair of erosion site prior to the next inspection.						
Inspector Comment						
This erosion isn't repaired to date. Large bush growing in eroded gully. Needs repairing.

This erosion site along the landside slope levee 0.32 has been reported and has not been repaired.

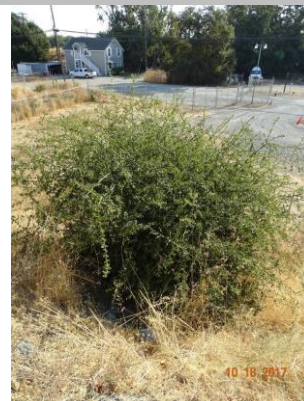
Photo 3 of 3 : FA_2018_RD0554_176_13_20180925_00004.jpg

This erosion is not repaired to date. Large bush growing in eroded gully. Needs repairing.

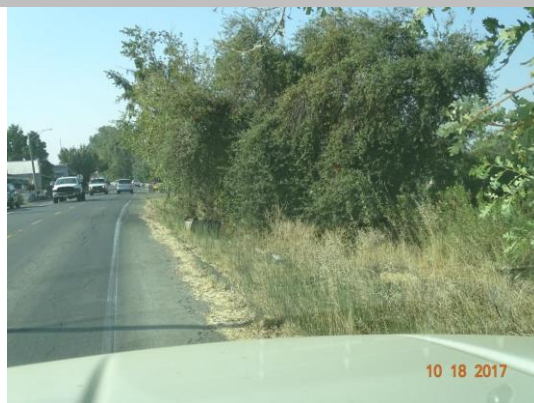
Photo 1 of 1 : FA_2018_RD0554_176_32_20180925_00008.jpg

LM Start	0.45	Rating **	M	Issue No.	32
LM End	0.49	Issue Type +	Ma	Location *	WS
Category	Earthen Levee			GPS Latitude/Longitude	
				Start	End
Item	Vegetation			38.243818 °	38.243389 °
				-121.512459 °	-121.512919 °
DWR ID	DWR_RD0554_01_f_2017_32				
Comment Code					
V2 : Remove the wild growth other than native grasses from the levee slopes.					
Inspector Comment					
Waterside vegetation should be cleared to 20 feet from crown for inspection and access.

Waterside vegetation should be cleared to 20 feet from crown for inspection and access.
